## **Tree Health & Condition Assessment Report**

**Site: 57 Stock Route, MANSFIELD.**

**Prepared for: Millar Merrigan.**

**22 April 2025: V1**

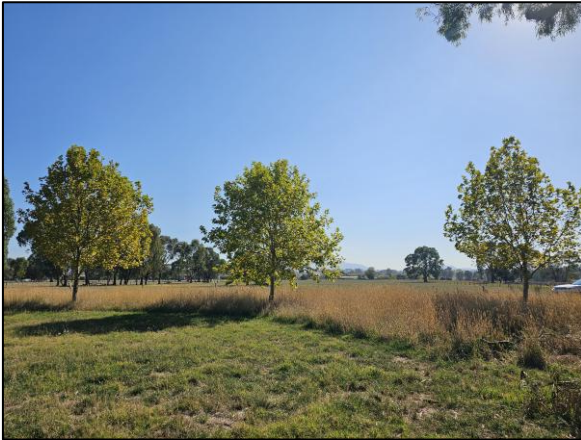
**Figure 3:** Showing Trees 3, 4 & 5.

3	<i>Platanus x acerifolia</i> (London Plane)	Exotic	Semi-mature	7	4	18	2.2	14.7	20	1.7	Good	Good	Long	Mod.	
4	<i>Platanus x acerifolia</i> (London Plane)	Exotic	Semi-mature	7	4	19	2.3	16.3	20	1.7	Good	Good	Long	Mod.	
5	<i>Platanus x acerifolia</i> (London Plane)	Exotic	Semi-mature	8	4	22	2.6	21.9	25	1.8	Good	Good	Long	Mod.	
6	<i>Platanus x acerifolia</i> (London Plane)	Exotic	Semi-mature	7	5	21	2.5	20.0	25	1.8	Good	Good	Long	Mod.	
7	<i>Platanus x acerifolia</i> (London Plane)	Exotic	Semi-mature	8	5	25	3.0	28.3	30	2.0	Good	Good	Long	Mod.	
8	<i>Eucalyptus camaldulensis</i> (River Red Gum)	Indig.	Mature	16	9	157	15.0	706.9	180	4.2	Poor/ Fair	Poor	Short	Low	Tree appears highly stressed, mod to high volume epicormic shoots, low volume deadwood. Crown is predominately epicormic regrowth off an old stump.
9	<i>Eucalyptus camaldulensis</i> (River Red Gum)	Indig.	Mature	14	17	130	15.0	706.9	170	4.1	Fair/ Good	Fair/ Good	Long	High	Tree appears in fair to good condition overall with a wide spreading crown. Low volume epicormic shoots, with low to moderate volume deadwood. No significant structural issues or defects within the main trunk bole and main scaffold leaders, fair to good vigour.

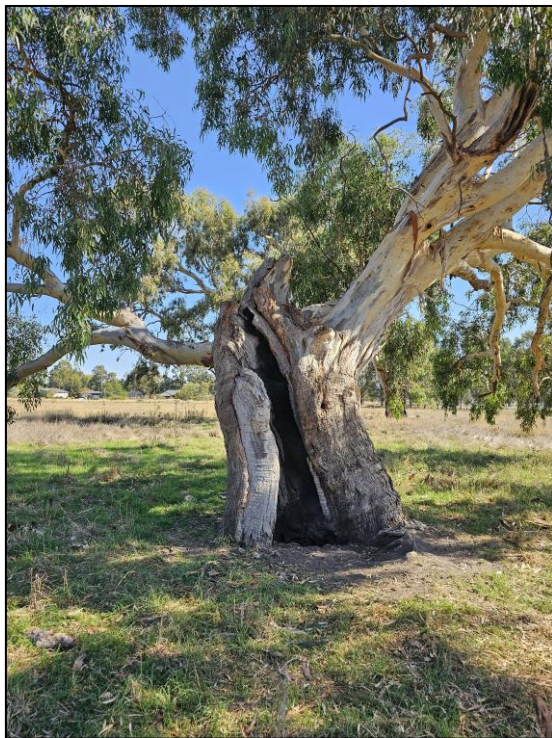
**Figure 7:** Showing Tree 10

10	<i>Eucalyptus camaldulensis</i> (River Red Gum)	Indig.	Mature	12	21	151	15.0	709.9	185	4.3	Fair	Poor	Short	Low	Tree appears highly stressed, mod to high volume epicormic shoots, low volume deadwood. Has lost the main central leader some years ago.
11	<i>Eucalyptus camaldulensis</i> (River Red Gum)	Indig.	Mature	18	20	141	15.0	706.9	170	4.1	Poor/ Fair	Poor	Short	Low	Tree appears highly stressed, mod to high volume epicormic shoots, mod volume deadwood. History of large primary branch failures. Large cavity inn lower trunk, significant cambial dieback lower trunk.

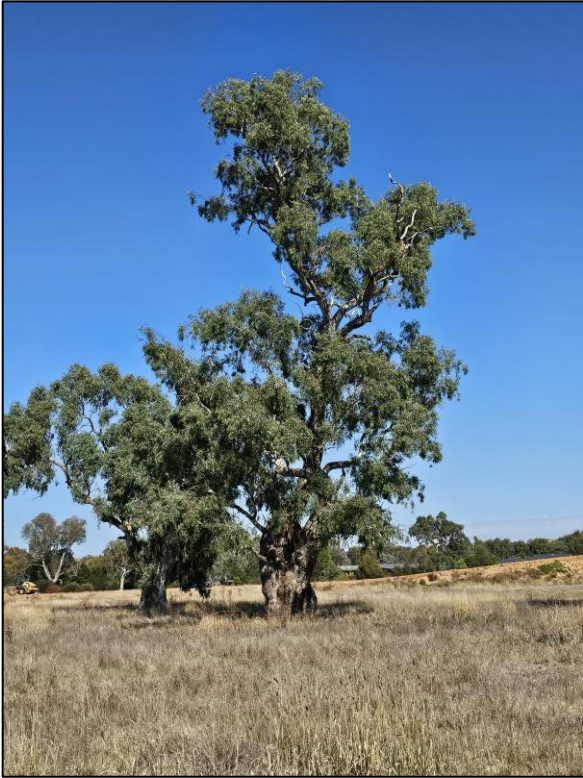
**Figure 9:** Showing Trees 12 & 13

Tree #	Botanical Name (Common Name)	Origin	Age	Height (m)	Spread (m)	DBH (cm)	TPZ (m)	TPZ area (m <sup>2</sup> )	DaB (cm)	SRZ (m)	Health	Structure	ULE (years)	Retention Value	Comments
12	<i>Eucalyptus camaldulensis</i> (River Red Gum)	Indig.	Mature	20	12	182	15.0	706.9	210	4.5	Poor	Fair	Short	Low	Moderate volume deadwood, High volume epicormic shoots, history of large branch failures although trunk bole sound.
13	<i>Eucalyptus camaldulensis</i> (River Red Gum)	Indig.	Mature	10	11	147	15.0	706.9	170	4.1	Poor/ Fair	Fair	Short	Low	Central leader has failed some years ago, crown consist predominately of epicormic shoots and deadwood throughout.
14	<i>Eucalyptus camaldulensis</i> (River Red Gum)	Indig.	Mature	21	16	156	15.0	706.9	180	4.2	Good	Good	Long	High	Tree appears in fair to good condition overall. No obvious signs of significant structural faults in the main trunk bole and main scaffold leaders. Low volume smaller deadwood, good vigour.

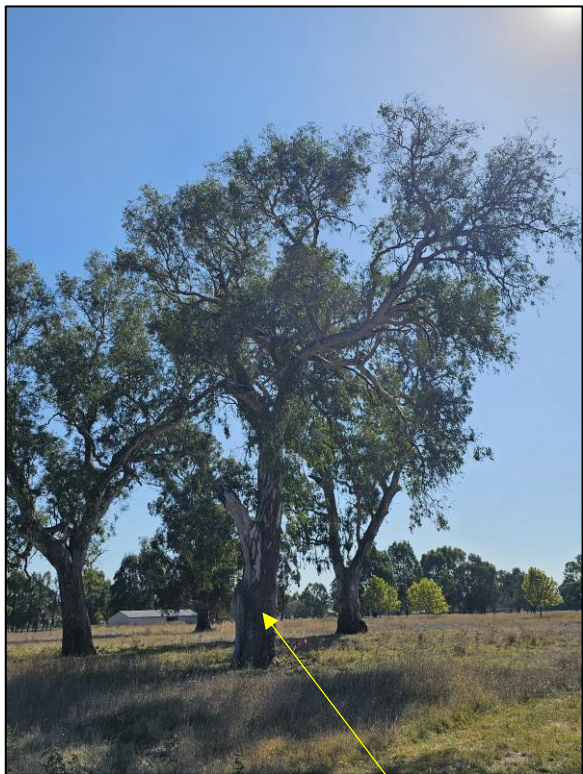
**Figure 15:** Showing Tree 19

19	<i>Eucalyptus camaldulensis</i> (River Red Gum)	Indig.	Mature	18	14	140	15.0	706.9	200	4.4	Poor/ Fair	Fair	Short	Low	Low volume deadwood, High volume epicormic shoots, cambial dieback on lower trunk – appears stressed.
20	<i>Eucalyptus camaldulensis</i> (River Red Gum)	Indig.	Mature	22	17	142	15.0	706.9	190	4.3	Poor/ Fair	Fair	Med.	Mod.	Sparse canopy cover, moderate to high volume epicormic shoots, moderate volume deadwood, Sound within main trunk bole and sound main scaffold attachment.
21	<i>Eucalyptus camaldulensis</i> (River Red Gum)	Indig.	Mature	26	21	186	15.0	706.9	220	4.6	Fair	Fair/ Good	Long	High	Tree appears in fair to good condition overall. Low volume epicormic shoots, with low to moderate volume deadwood. No significant structural issues or defects within the main trunk bole and main scaffold leaders.
22A	<i>Eucalyptus camaldulensis</i> (River Red Gum)	Indig.	Mature	27	20	170	15.0	706.9	190	4.3	Fair	Fair/ Good	Long	High	Tree appears in fair to good condition overall. Low volume epicormic shoots, with low to moderate volume deadwood. No significant structural issues or defects within the main trunk bole and main scaffold leaders.

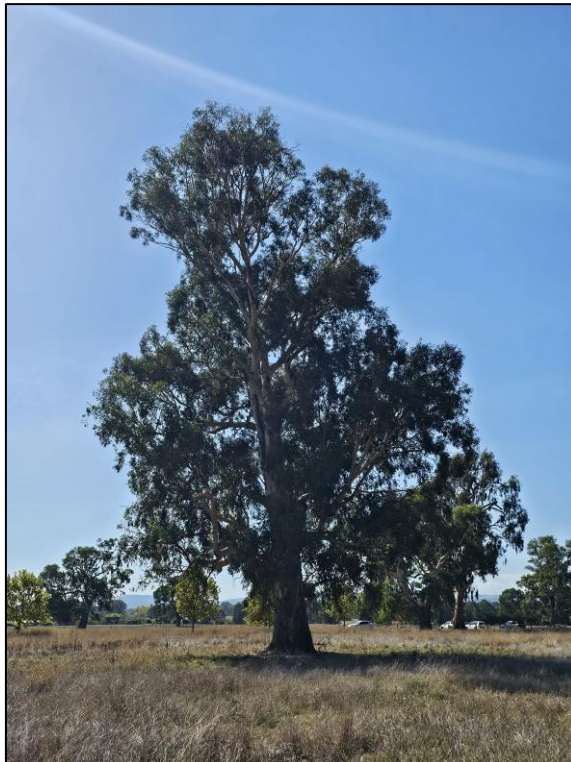
**Figure 19:** Showing Tree 22B

22B	<i>Eucalyptus camaldulensis</i> (River Red Gum)	Indig.	Mature	22	18	155	15.0	706.9	170	4.1	Fair	Fair/ Good	Long	High	Tree appears in fair to good condition overall. Low to moderate volume epicormic shoots, with low volume deadwood. No significant structural issues or defects within the main trunk bole and main scaffold leaders. Infested with Lerp/Psyllid.
23	<i>Eucalyptus camaldulensis</i> (River Red Gum)	Indig.	Mature	24	18	190	15.0	706.9	210	4.5	Poor/ Fair	Fair	Med.	Mod.	Sparse canopy cover, moderate to high volume epicormic shoots, moderate volume deadwood, Sound within main trunk bole and sound main scaffold attachment.

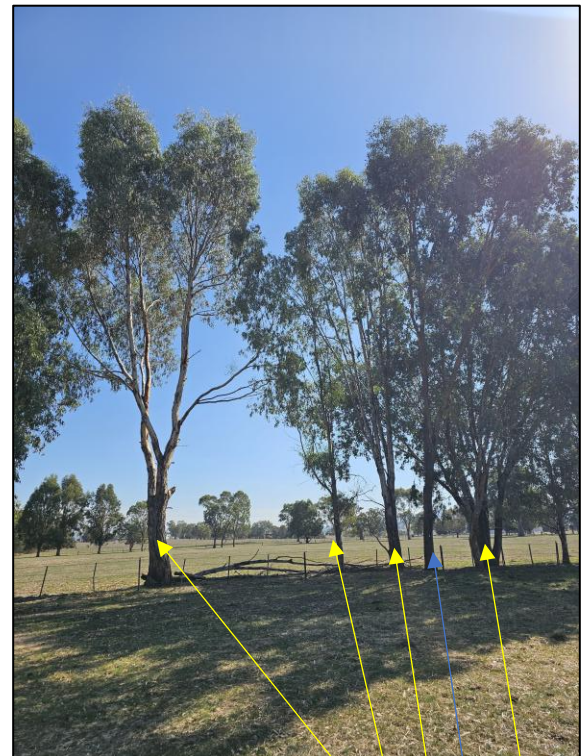
**Figure 24:** Showing Trees 30, 29, 28, 27 & 26

29	<i>Eucalyptus camaldulensis</i> (River Red Gum)	Indig.	Semi-mature	14	7	46	5.5	95.7	50	2.5	Good	Good	Long	High	Neighbours tree
30	<i>Eucalyptus camaldulensis</i> (River Red Gum)	Indig.	Semi-mature	11	5	23	2.8	23.9	30	2.0	Poor	Fair	Short	Low	Neighbours tree
31	<i>Eucalyptus camaldulensis</i> (River Red Gum)	Indig.	Semi-mature	15	12	53	6.4	127.1	70	2.8	Good	Good	Long	High	Neighbours tree
32	<i>Eucalyptus camaldulensis</i> (River Red Gum)	Indig.	Semi-mature	14	9	51	6.1	117.7	70	2.8	Good	Good	Long	High	Neighbours tree
33	<i>Eucalyptus baueriana</i> (Blue Box)	Vic. Native	Semi-mature	8	7	39	4.7	68.8	50	2.5	Fair/ Good	Good	Long	High	Neighbours tree
34	<i>Eucalyptus camaldulensis</i> (River Red Gum)	Indig.	Mature	14	10	61	7.3	168.3	70	2.8	Good	Good	Long	High	Neighbours tree
35	<i>Eucalyptus baueriana</i> (Blue Box)	Vic. Native	Semi-mature	9	9	37, 22	5.2	83.6	50	2.5	Good	Fair	Long	Mod.	Neighbours tree

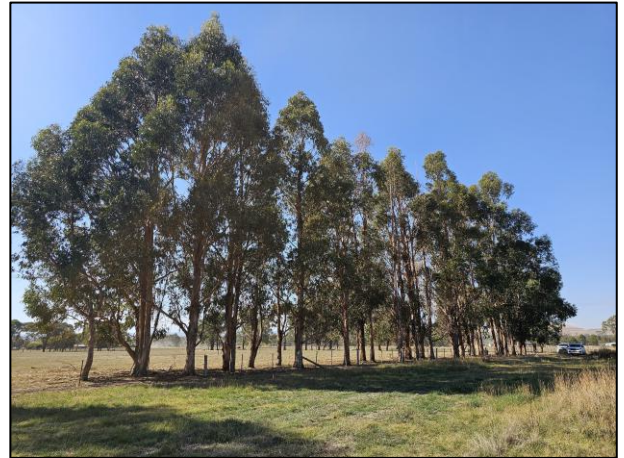
**Figure 28:** Showing Tree Group 40.

TG40	<i>Eucalyptus globulos subsp. bicostata</i> (Eurabbie)	Vic. Native	Semi-mature	17	6	40	4.8	72.4	50	2.5	Fair	Good	Long	High	Group of approximately 50 trees planted along the fence line within the adjoining property in rows about 3 deep. They range in heights from 12 to 17m with an average canopy spread of 6 to 7m. Their DBH @ 1.4m above ground is up to 40cm. Their overall condition ranges from fair to good with just the single dead tree observed. Their structure is generally sound and are predominately single trunk specimens.
