Final Report

November 2005

Earth Tech Engineering Pty Ltd ABN 61 089 482 888 Wangaratta Office 54 Ovens Street Wangaratta VIC 3677 Tel +61 3 5722 3300

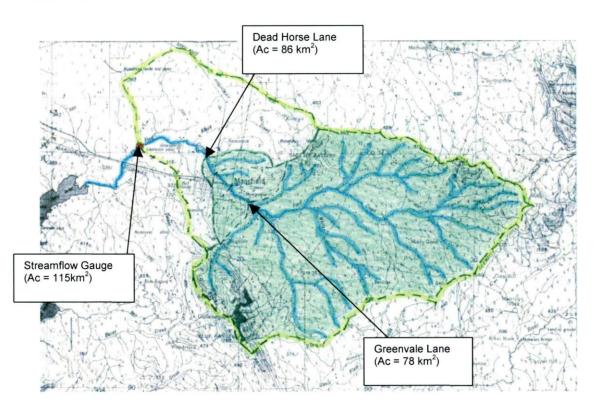
The Ford Creek catchment upstream of Mansfield is shown on Figure 2.1. The creek has a catchment area of 84 km² at the Highett Street bridge in Mansfield. The township has a population of 2,300.

Ford Creek outfalls into Lake Eildon approximately 7 km downstream of Mansfield. The only streamflow measurement station on Ford Creek is located midway between Mansfield and Lake Eildon (refer Figure 2.1).

The catchment area draining to the gauge site is 115 km² (refer Figure 2.1). The estimated approximate lag between flooding peaking in Mansfield and peaking at the gauge site is 1 hour.

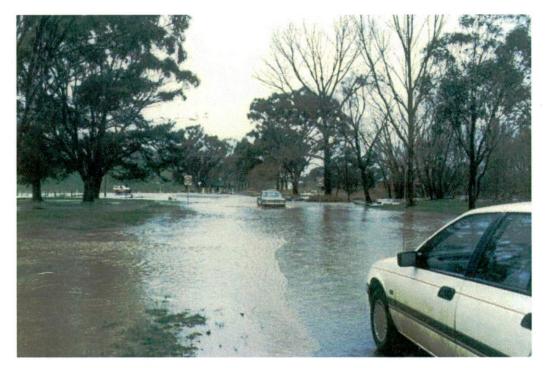
Photograph 1 High Street looking towards the Mount Battery Road intersection – 18 July 1990 (approximately 5-year ARI flood)

The modelled 1990 flood High Street road overflows west of the Mount Battery Road intersection based on the same model set-up and parameter values adopted for the 1975 flood calibration is 9 m³/s and coincides with a maximum depth of overtopping of 0.25 metre. This would appear to be similar to conditions in Photograph 1. The hydraulic model indicates that Mount Battery Road east of the High Street intersection is only very marginally overtopped (flow less than 0.5 m³/s).

- The 2-year ARI event was adopted as the threshold event at which flood damages commence to occur. In a 5-year ARI event, there is considerable out of channel flooding within the study area (e.g. refer to Photograph 1 which shows High Street overtopped in a 5-year ARI event).
- The 10-year ARI event was adopted as the event coinciding closest with the extent of the floodway area as determined by the hydraulic analysis and flood mapping carried out for this study.
- Flood damages were computed for the 10 and 100-year ARI floods consistent with the flood extent mapping carried out for this study.

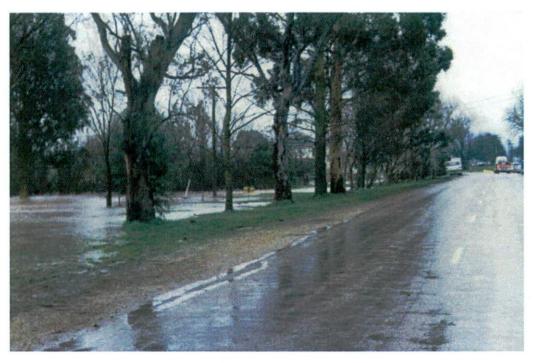
Photograph 2

High Street looking towards the Ford Creek bridge – 18 July 1990 (approximately 5-year ARI flood)

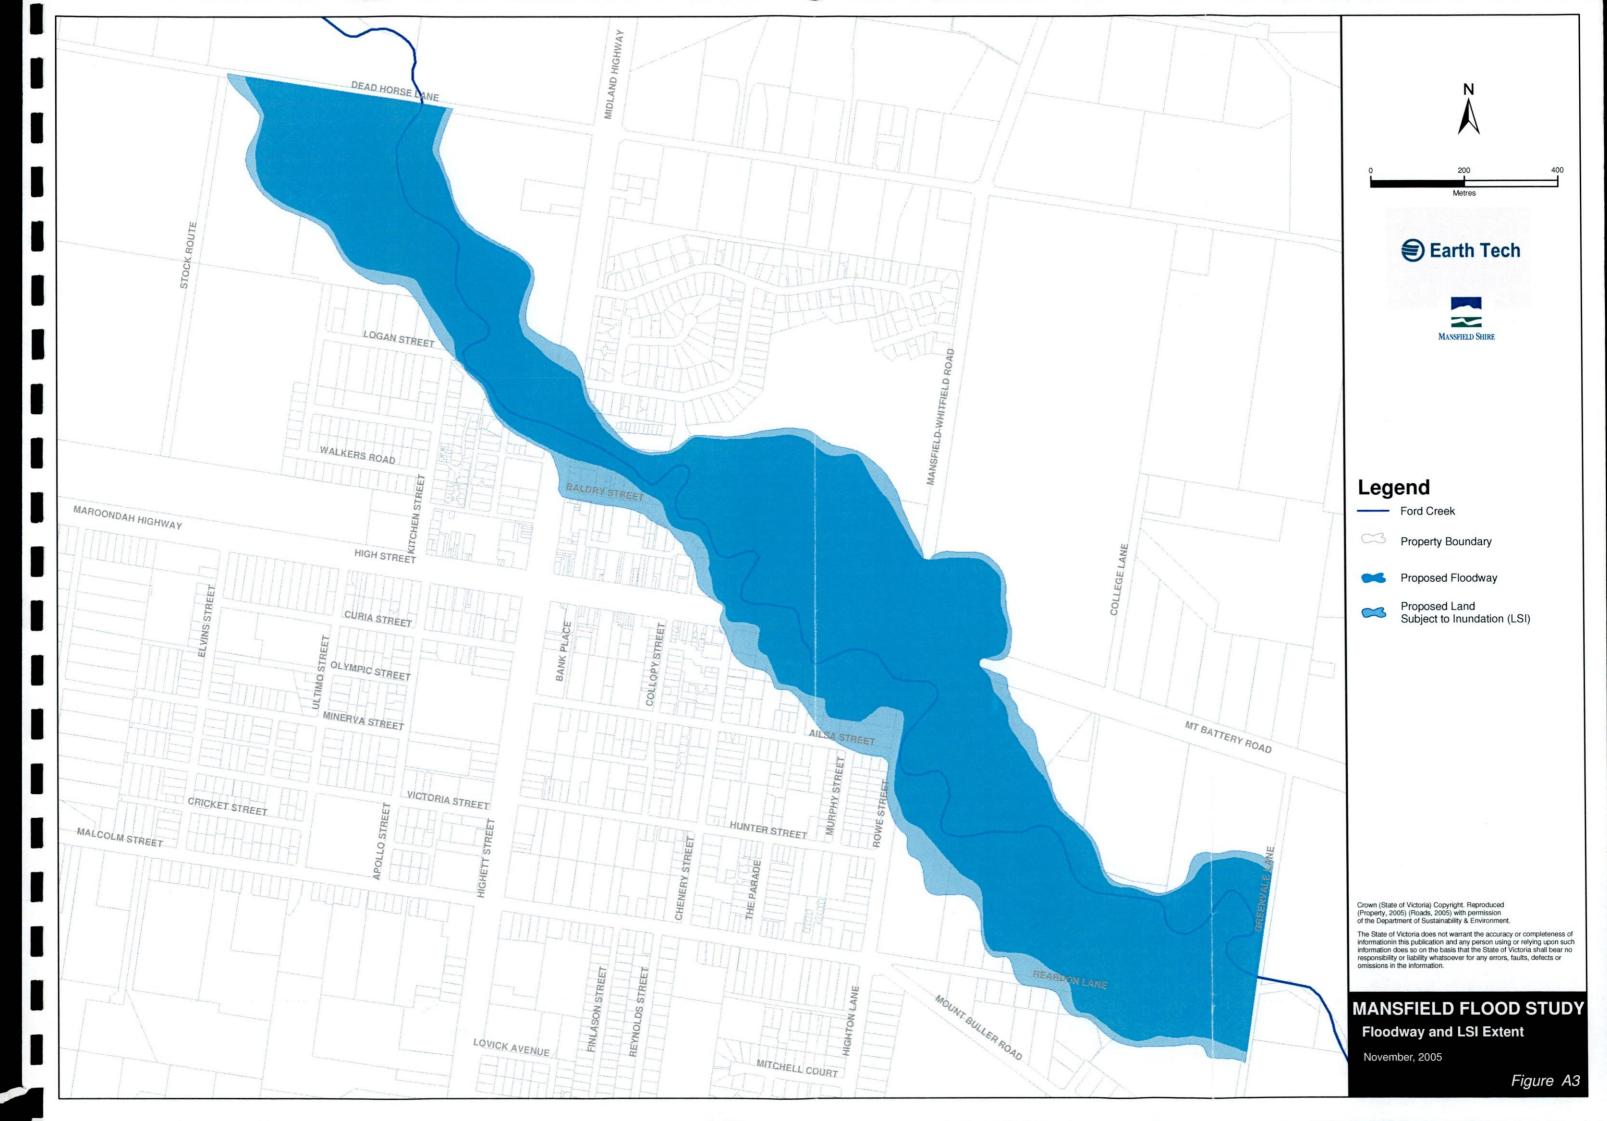
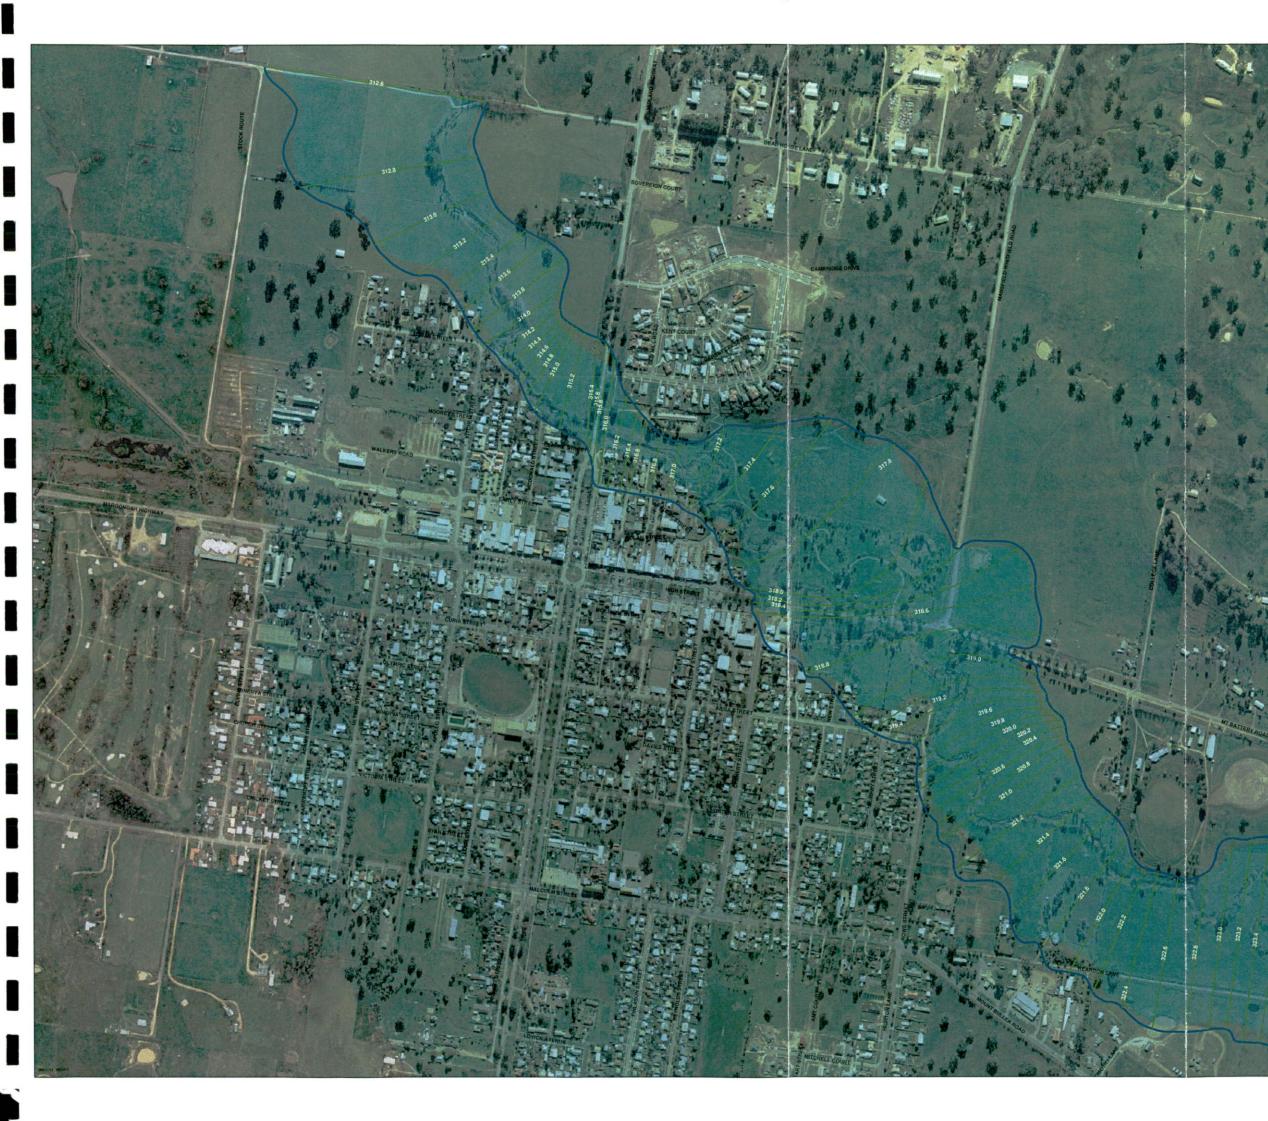
> Drawing Number: 540258 November 2005

The flood levels were declared by the Goulburn Broken Catchment Managment Authority on the _____ under the provisions of the Water Act 1989.

FORD CREEK - MANSFIELD Designation of Flood Levels

Recommendation: The newly defined 100-year ARI flood level contours and flood extents are to be added to the Victorian Flood Database and adopted by the Mansfield Shire Council and the Goulburn Broken CMA for planning control purposes. The Goulburn Broken CMA are to declare the 100-year ARI flood level contours under the provisions of the Water Act, 1989.
